Attachment J

PND 122085

Re: Yakutat Seafoods Wash House
Structural Condition Assessment

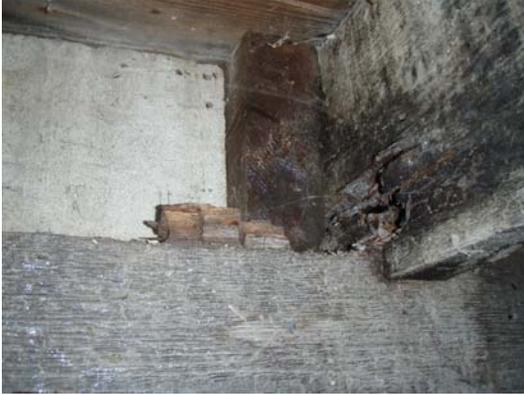
- 3) Floor joists are rotten at supports with significant crushing. Some joists have fungal growths on them.
- 4) Timber floor deck has fungal growth on the underside.

Rotten end of floor joist – Note crushing.

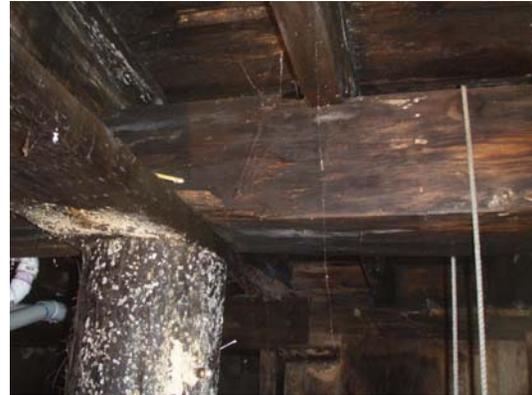
- 1) Timber piles are saturated and have fungus on the surface.
- 2) Timber pile caps have failed in compression and one is cracked vertically. Although the creosote treatment protects the outer surfaces of the timbers the interior are rotten and crumble when probed.

Cracked and crushed pile cap

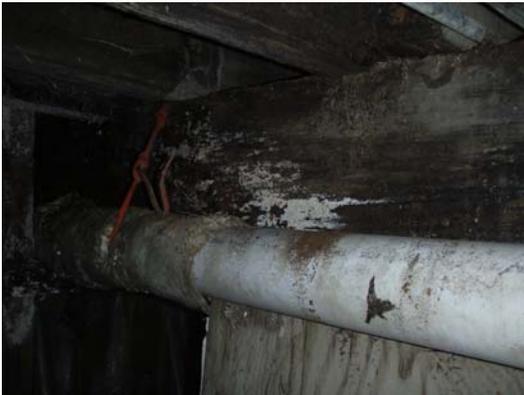
Fungus on pile cap

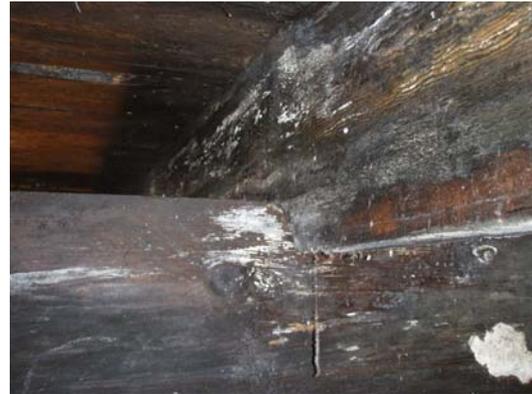
Crushed joist, fungus on joist and cap

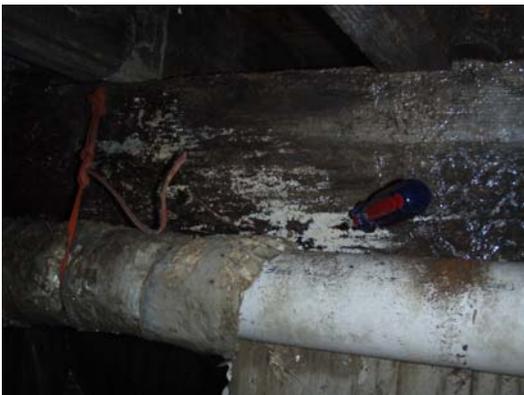
Rotten pile cap penetrated by screwdriver

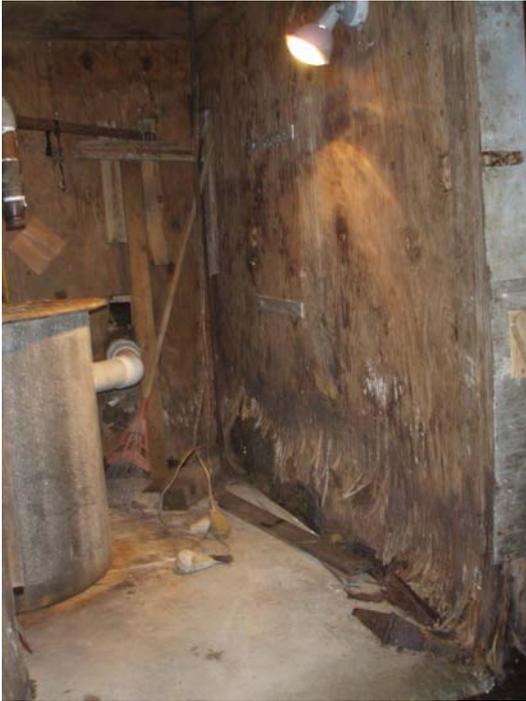
- 8) The compressor in the sprinkler room no longer functions. A small electric heater keeps the space relatively dry.
- 9) The timber supporting the sewage pump room slab is rotten and is failing.

Failed sheathing at sewage pump station room

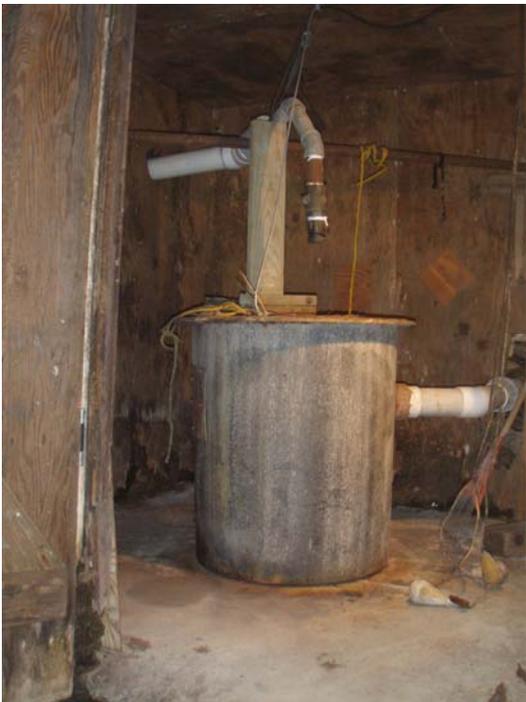
Sewage pump wet well- note float controls on floor

- D) Install a slab over a relatively thick vapor barrier in the crawl space.
- E) Relocate the sewage pump station room to the north side of the crawl space. Vent the room to the exterior. Replace the relatively small wet well with a larger wet well, sized for the volume of sewage anticipated. Have two pumps with appropriate alarms and level controls.

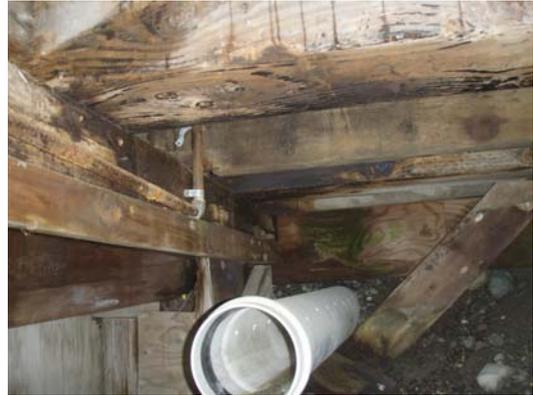
- 5) The ground surface in the crawls space is extremely wet and there is no vapor barrier on it. A foundation drain daylights and empties into the crawl space.

Foundation drain daylighting into crawl space

- A) Remove all debris from the crawl space.
- B) Install a foundation drain around the new crawl space. The drain should be perforated pipe that is surrounded with drain rock encased in a drainage geotextile. The perforated pipe should be extended to the tidewater east of the Wash House.

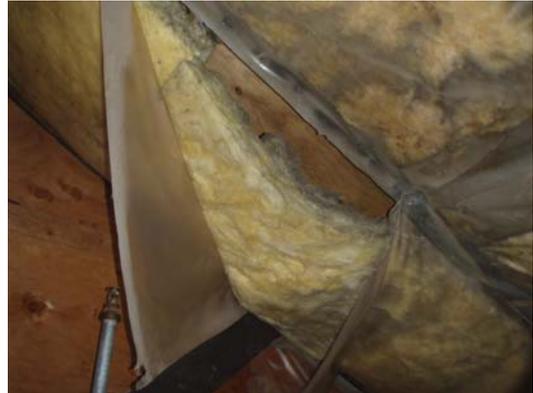
- 12) In the western part of the building one truss appears to have been removed and another has been severed so that it is not supported on one end.
- 13) Insulation and vapor barriers at the roof in the western part of the structure appear damaged. It appears the roof has leaked.

Damaged vapor barrier and insulation

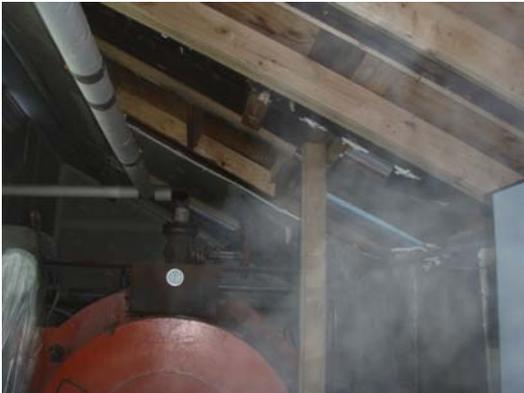
- 11) The roof framing in the eastern part of the building appears to have significant problems. Locations where stacks or flues penetrated the framing were poorly framed with headers not well connected to rafters. Many rafters have been sistered with 2x material.

Suspicious roof framing in east portion of roof

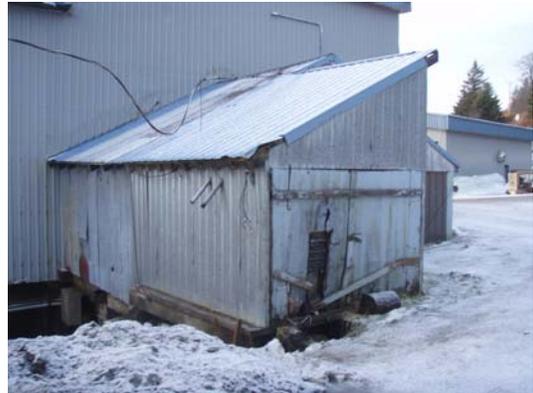
Deteriorated siding

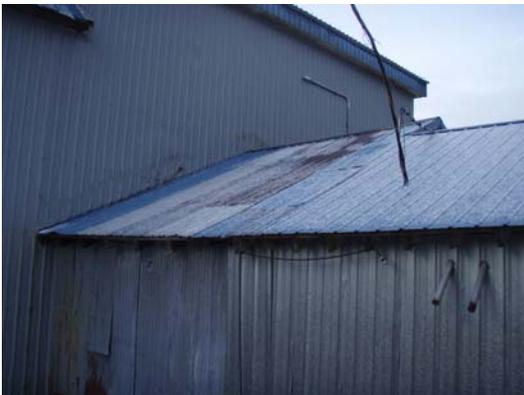
- 14) The corrugated metal roofing appears to be beyond its expected life. In places the coatings are depleted and the roofing is corroded. The roofing has been damaged from falling snow and ice off the adjacent building's higher roof.
- 15) Building metal siding is beyond its expected life. It is damaged in many places.
- 16) Grading north and west of the building causes surface water to drain into the crawl space. Maintenance workers have installed a surface drain on the west side of the structure.
- 17) The north edge of the adjacent building abuts the wash house. West of the wash house earth spills into the main building crawl space. This is approximately 6 feet high and 10 feet long.

Deteriorated roofing east side

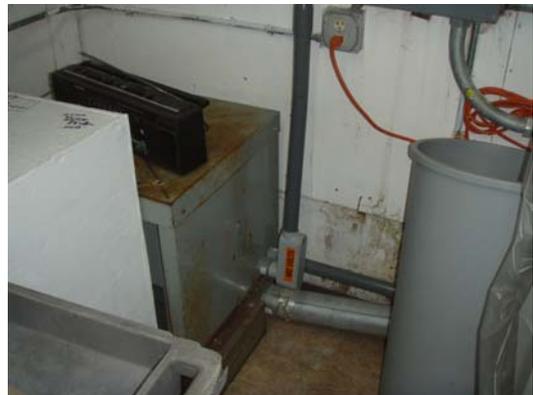
Transformer without proper clearance

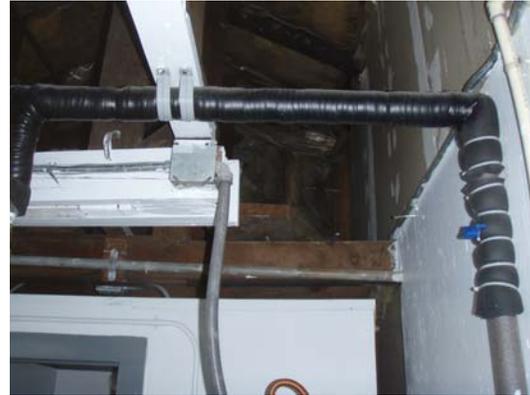
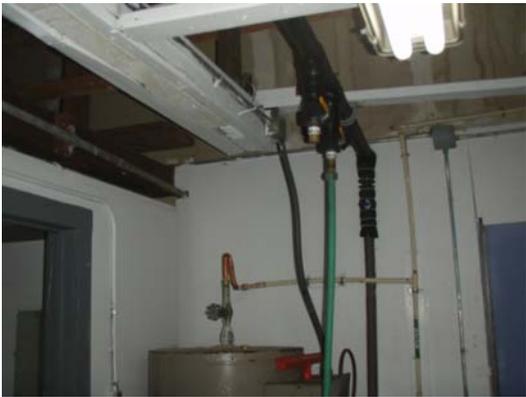
Another view of severed roof truss

Severed roof truss
