Haines Borough - High School Roof

Haines High School Roof Report

August 13

Prepared By:
Tony Yorba,
CEFPI, RCI

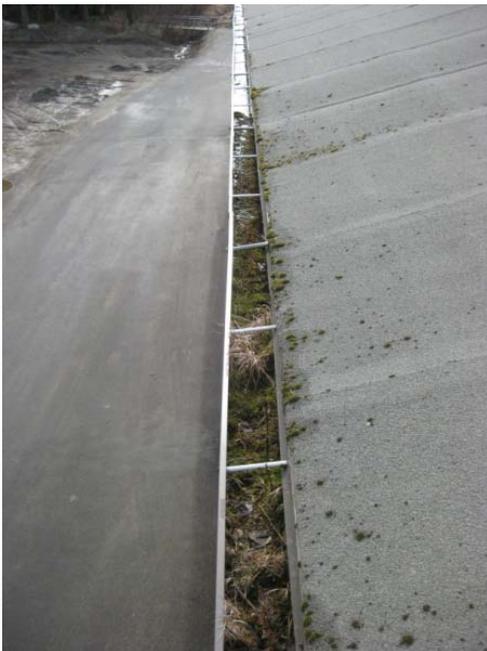
Moss filled gutters.

1. Clean moss and dirt out of gutters.
2. Seal leak in downspout on south facing gutter, low end of roof.
3. Re-seal modified bitumen and EPDM at metal flashing between pool roof and gymnasium roof.
4. Repair cracks in membrane and at membrane to wall connection at south wall transition to concrete wall at gymnasium.
5. Curb transition membrane flashing was cracked or had membrane separation at several roof mounted exhaust fans and should be repaired.

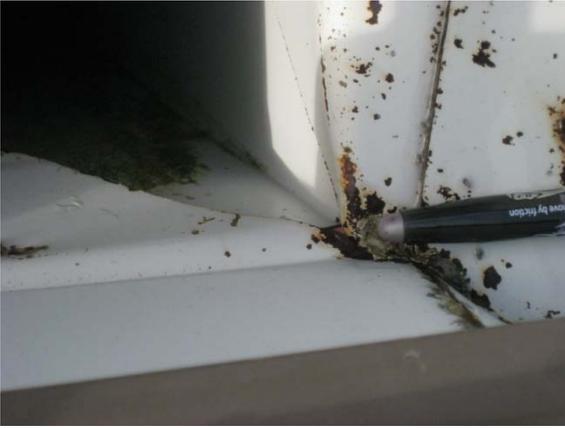
Leak point in gutter.

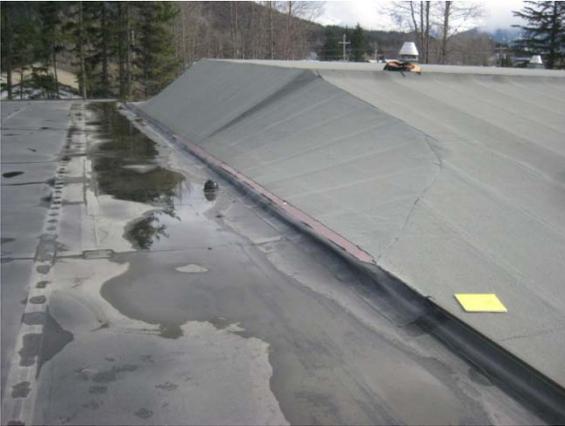
Potential leak point between gym roof and pool roof.

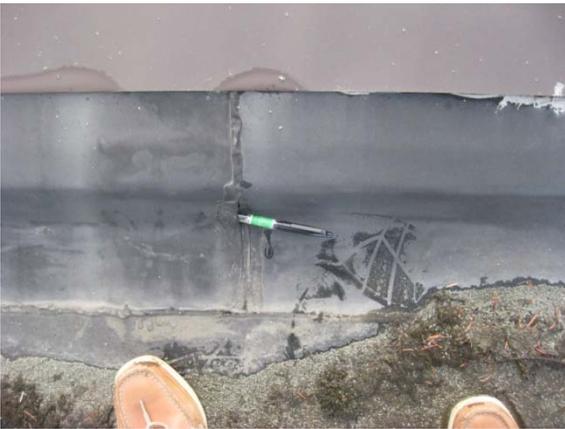
Close up of potential leak point between gym roof and pool roof.

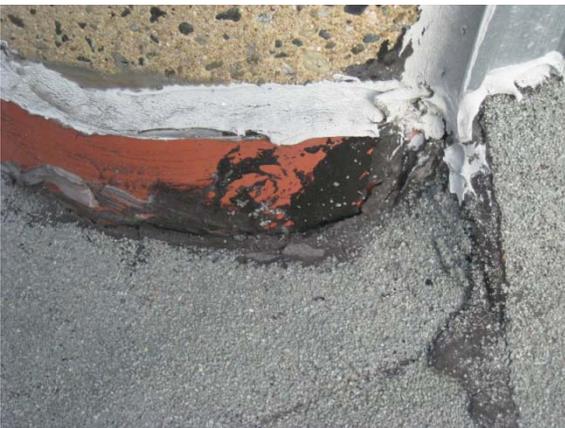
Leak point between pool roof and concrete wall.

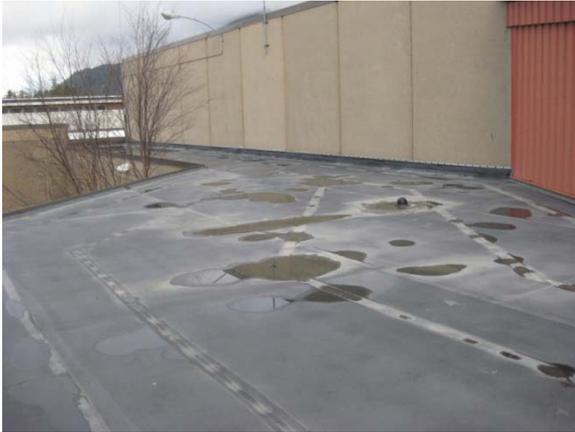
Overall view, low roof at entry hall – note ponding

3. Roof ponds due to distance to roof drain- install additional roof drain and daylight to grade if ponding worsens
4. Keep surveillance of membrane transition detail at roof edge shared with the music room.
5. Several seams were observed that were beginning to fail and should be cleaned and resealed.

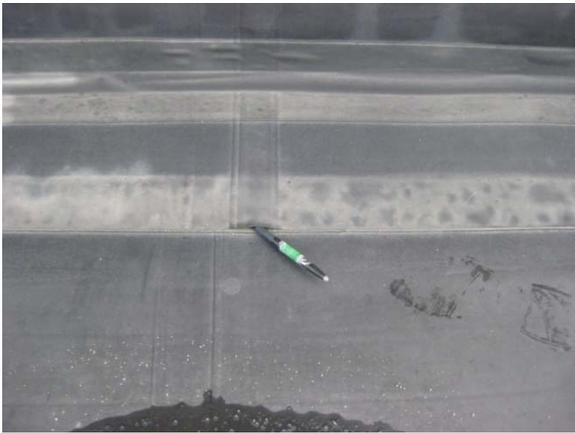
Potential failed seam.

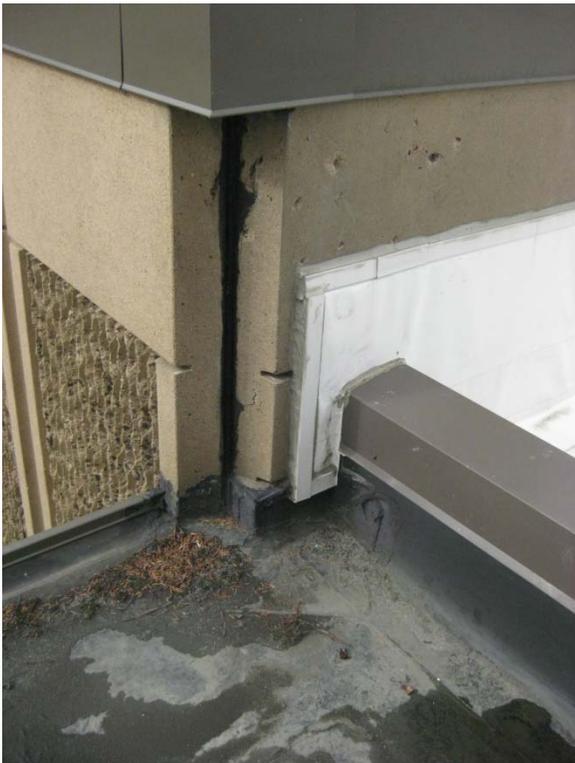
Potential leak point at intersection with music room.

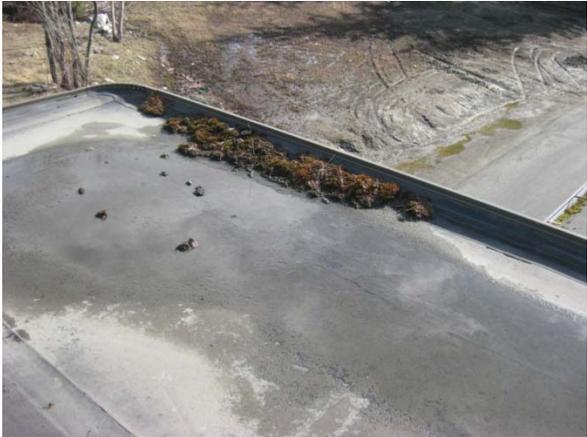
Moss buildup.

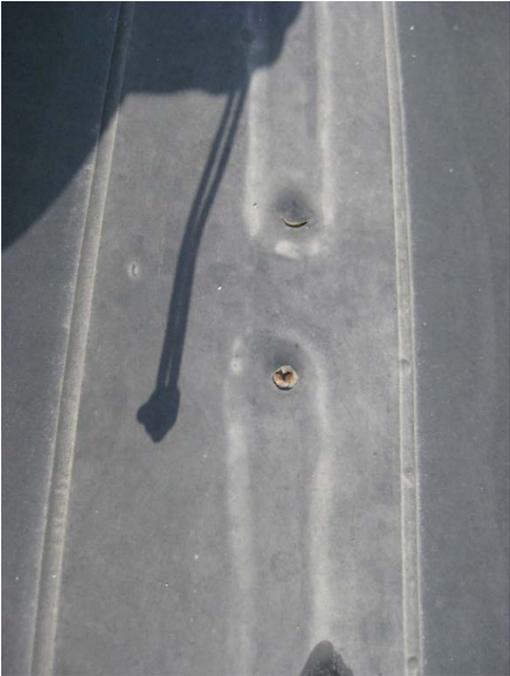
Membrane damage at protruding fasteners.

1. Clear moss and sludge from roof surface to keep roof drains clear and to assist with maintenance.
2. Reset and patch fasteners that protrude from the roof substrate as much as 3/8 inch in many areas. Observed 5 in a row where the membrane was torn above them, north side, approximately 24 inches from the parapet, approximately 20 feet from the west end of building.
3. No overflows are provided, current code requires them.
4. Found two areas where the substrate board was either very soft, or bowed as much as two inches. Both conditions are associated with water intrusion. It may be warranted to cut the membrane and determine the cause of the condition. One area is immediately adjacent to the south roof drain. The other is in the southwest corner of the roof. It is assumed the soft areas must be cut and replaced.

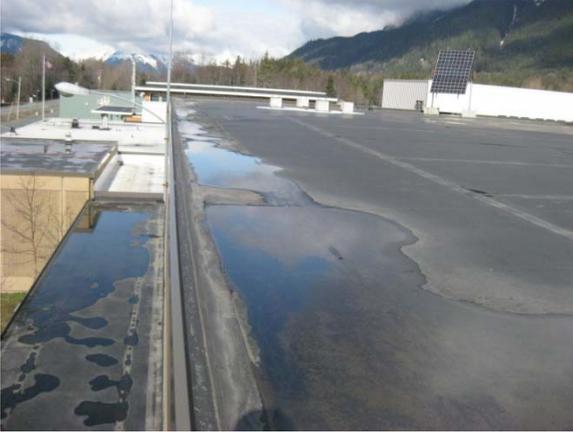
Area where soft roof substrate was encountered.

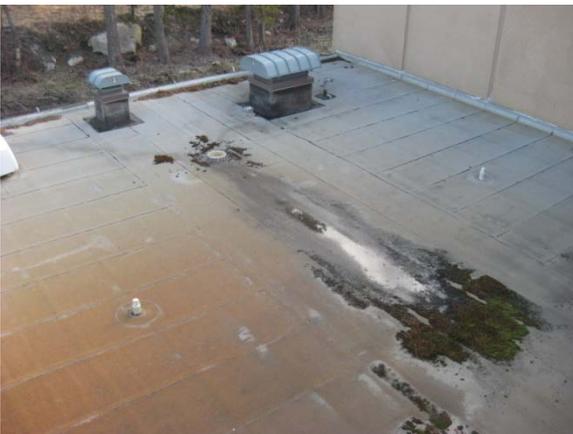
Overall view of Area 4. Roof with moss buildup at roof drain.

1. Moss, dirt and sludge should be cleared to ensure operation of the single roof drain, and to facilitate maintenance.
2. Parapet cap is rust stained, but it is only superficial and can be removed from the surface of the paint. Rust is residue from boiler stacks that were removed from the area.

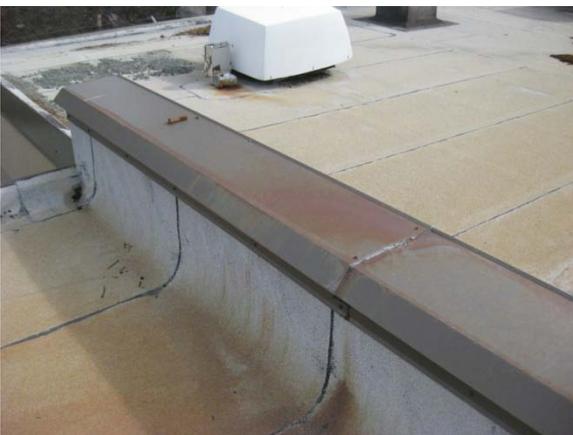
Rust stain at parapet.

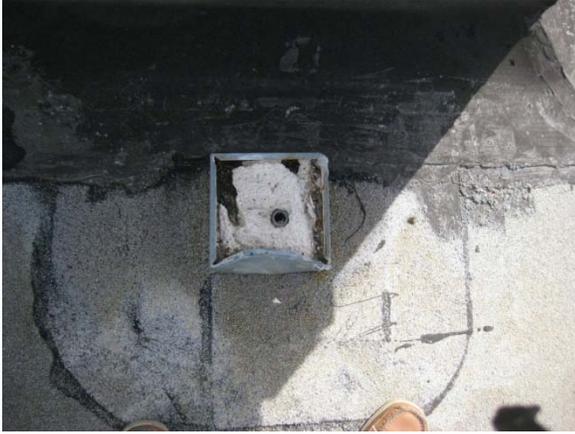
Failed pitch pocket.

3. Pitch pockets have failed. Some pitch pockets are no longer needed and should be removed. Those still needed should be replaced.
4. Keep metal and concrete walls under surveillance to ensure leaks do not develop at existing joints.

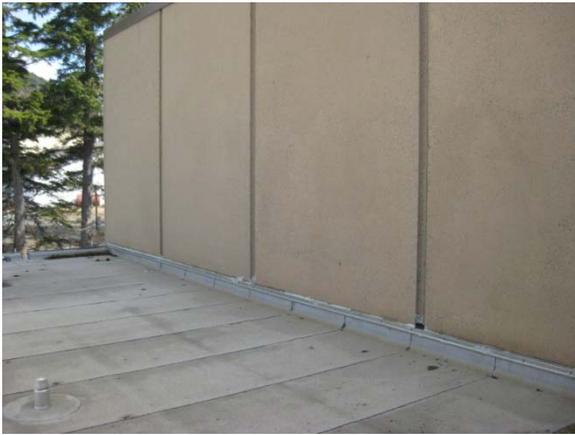
Potential leak point at concrete wall.

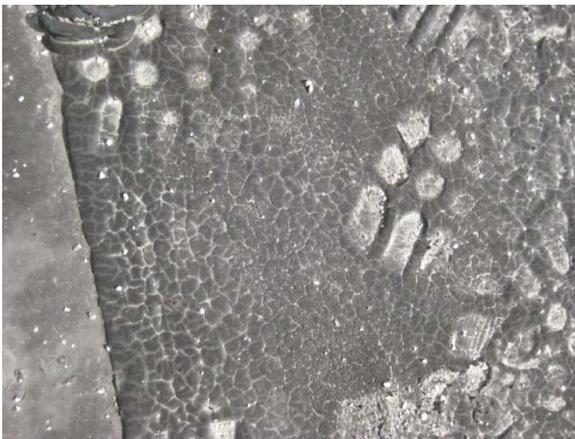
5. Some seams in the parapet wall shared with the main high school roof are failing and should be resealed.
6. Patching at mechanical equipment installed as part of recent school renovation was accomplished with non mineralized modified bitumen membrane. Alligatoring is already appearing where the aromatics in the membrane and asphaltic sealant evaporated. These should be monitored and corrected by placement of mineral granules if they worsen.

Failing asphalt sealant.

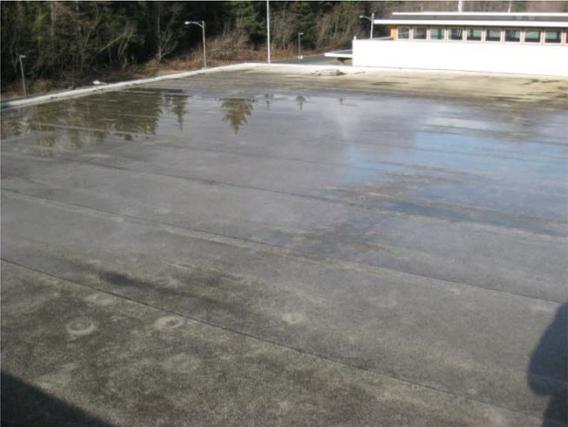
Overall view of Area 4 with ponding evident.

1. The roof is ponding significantly to the east. The roof structure may be deflecting from the load imposed by mechanical equipment suspended from the steel bar joist roof structure. Consideration should be given to adding a new roof drain which could be connected to the piping below the existing roof drain.
2. Roof to wall base flashing is loose at the wall shared with the gymnasium, and should be repaired.
3. Water cut off seal is failing at roof edge along parapets and should be replaced.

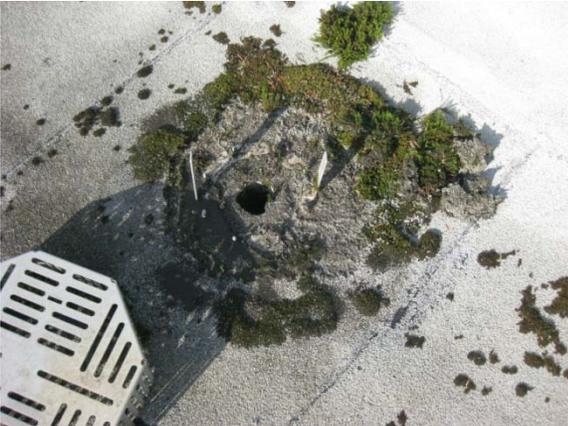
Moss buildup at roof drain.

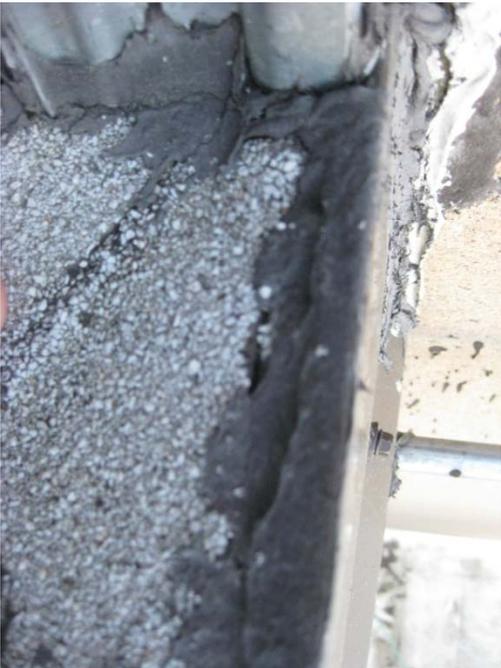
Leak point at adjacent structure.

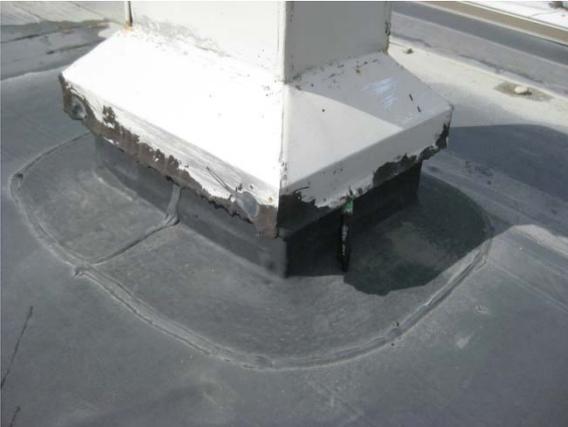
Leak point in roof penetration.

1. Keep moss and sludge off roof to facilitate maintenance.
2. Goose neck exhaust fan should be sealed- it appeared to have a gap between the metal flashing and the curb on the north side.
3. Only one roof drain exists here, add an additional roof drain

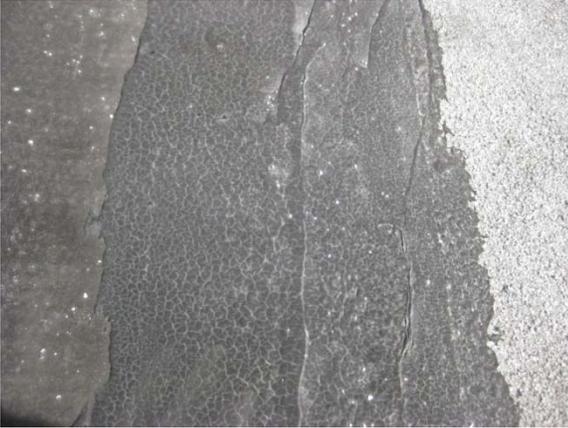
“Alligatoring” of four year old flashing surface.

1. Patching at mechanical equipment installed as part of recent school renovation was accomplished with non mineralized modified bitumen membrane. Alligatoring is already appearing where the aromatics in the membrane and asphaltic sealant evaporated. These should be monitored and corrected by placement of mineral granules if they worsen.
2. Maintain surveillance of the metal wall panels installed at the east side of the roof, as the vertical seams in these panels could allow water to defeat the perimeter seal and leak under the roof membrane.

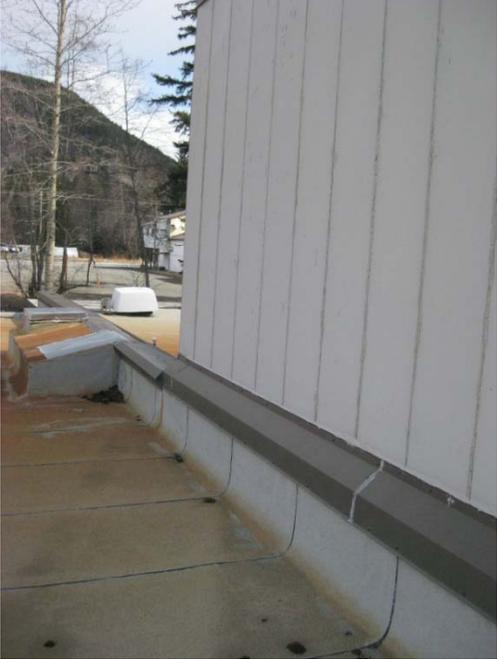
Potential leak point at wall seams.

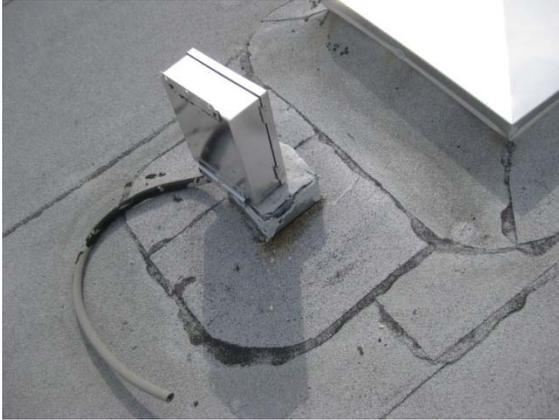
Failed pitch pocket.

3. Clear moss and sludge from roof surface and especially around roof drains to prevent a blockage.
4. Replace failed pitch pocket near abandon mechanical openings in the southwest corner of the roof.
5. Re-seal cracks in flashing around goose neck exhaust caps.
6. Moisture is present on a roof seam around a fish mouth the membrane seam about 25 feet from the west wall, midway between the north and south walls. The seam should be re-sealed.
7. Repair bubble in membrane approximately 4 feet from the east wall, 10 feet south of the corner of the upper level mechanical room.

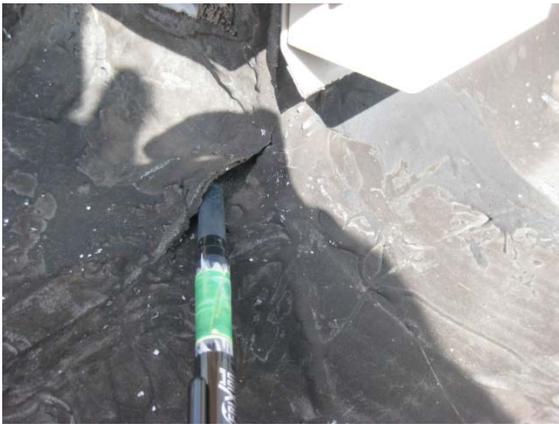
Seam failure at exhaust cap.
