Galena City School District - Student Residential Hall Roof Replacement

PTARMIGAN DORM RE-ROOF
PRELIMINARY REPORT
GALENA, ALASKA

February 3, 2011
Job No.: 09025.08

GALENA INTERIOR LEARNING ACADEMY
Ptarmigan Dorm Re-Roof
Report and Analysis

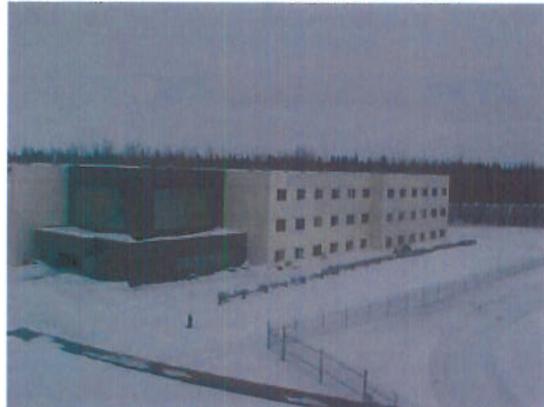
Due to ongoing maintenance concerns for the roof, Galena City Schools contracted with Architects Alaska to provide an evaluation of the existing roof and to make recommendations regarding the remaining useful life of the roof and for repairs necessary to extend its life or replacement.
