# Valdez Flooding Control Project

December 1, 2010  
W.O. 59578

Subject: Valdez Flooding Investigation  
[REDACTED]

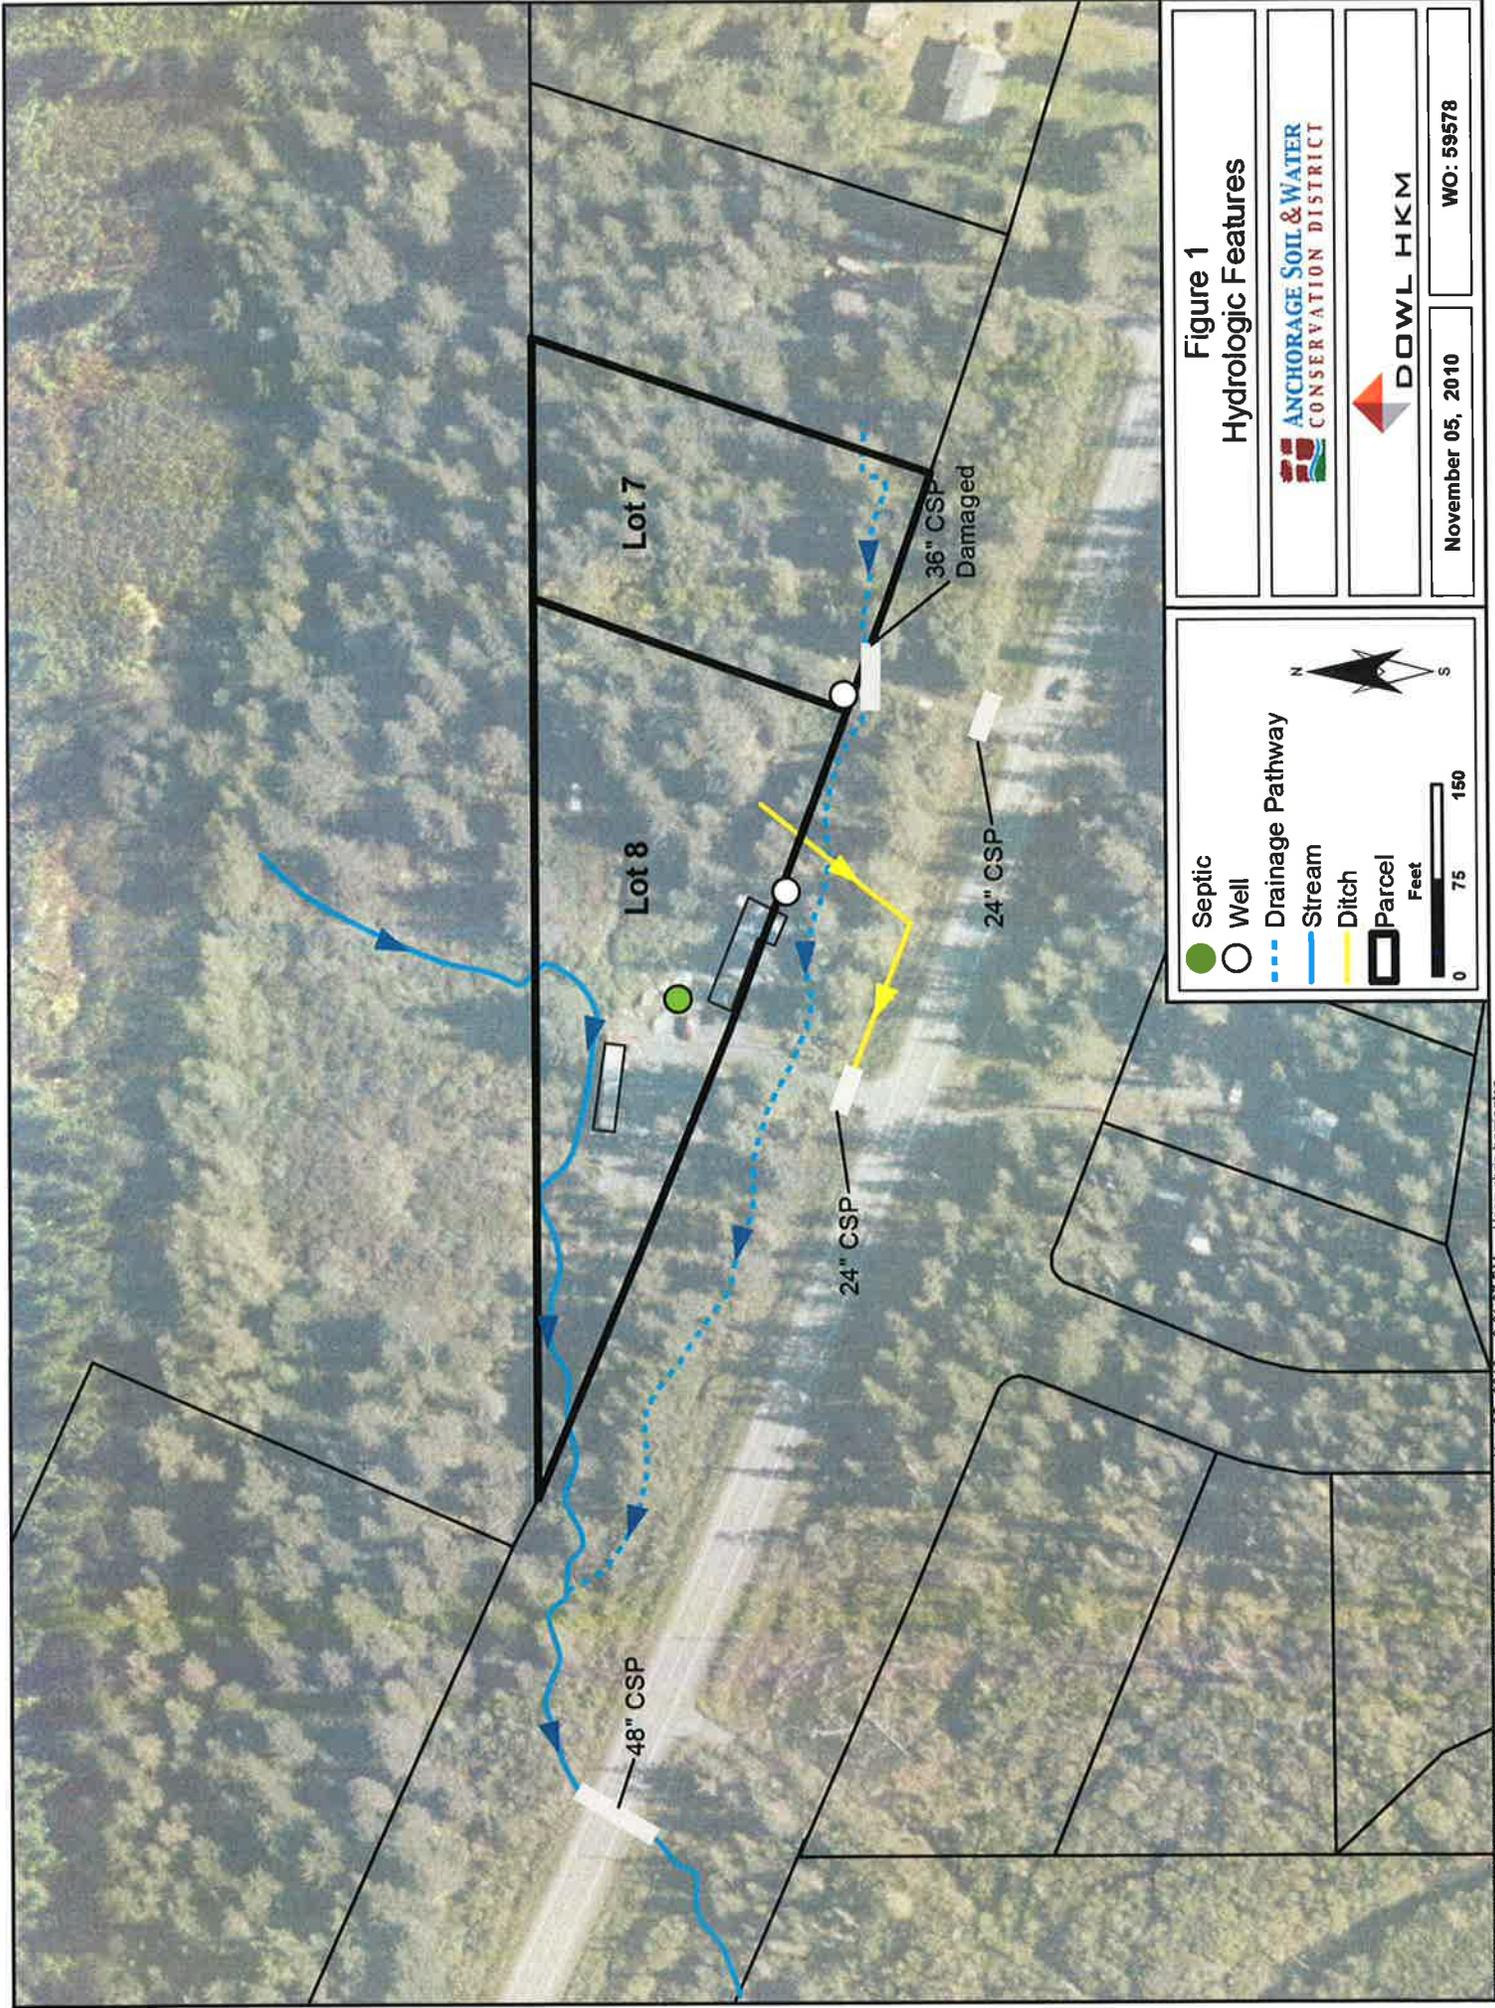
Figure 1  
Hydrologic Features

A stream draining from the mountains to the north of the property drains approximately west through the west half of Block [REDACTED]. The stream is located to the north side of the driveway and roughly follows the northern property boundary. The stream flows roughly southwest off of the [REDACTED] property onto the DOT&PF ROW and crosses the Richardson Highway through a 48-inch corrugated steel pipe (CSP) culvert approximately 600 feet to the west of Ms. [REDACTED] home. Based on an assumed slope of 2 percent, the hydraulic capacity of the culvert is estimated to be 110 cubic feet per second (cfs). The observed rust line at the inlet of the culvert is at approximately 20 percent of the culvert rise. The observed rust line at the outlet is at approximately 50 percent of the culvert rise. This suggests that the culvert experiences significant backwatering effects during high flows from the downstream channel and Lowe River. The observed gradient of the stream flattens significantly on the south side of the Richardson Highway as the stream nears the Lowe River. Substantial standing water in the form of marshes and sloughs was observed to the south of the highway. These downstream conditions support that theory that the stream channel downstream of the 48-inch culvert results in backwatering conditions affecting the stream on the north side of the highway.

A natural drainage pathway, including a roughly defined channel, was observed on the Olson property and adjoining DOT&PF property. The drainage pathway follows the natural topographic low point between the Richardson Highway and the mountains to the north, draining west through Lot [REDACTED] and Lot [REDACTED] to the stream at the existing 48-inch culvert in the highway. The drainage pathway runs approximately east-west through Lot [REDACTED] approximately 20 feet to the south of the approximate location where the trailer burned down. Two seeps were observed on the natural steep hill slopes along the north side of Lot [REDACTED]. Ms. [REDACTED] explained that these seeps are waterfalls during storm events and contribute runoff to the drainage pathway. There is an old 36-inch CSP culvert in the gravel driveway to Lot [REDACTED]. This culvert was partially damaged by City of Valdez during efforts to remove debris following the 2006 flood, but the culvert still functions to some extent. The drainage pathway runs approximately 20 to 30 feet south of the existing house on Lot [REDACTED] and crosses the gravel drive at an existing low point. The crushed remnants of an 8-inch clay culvert were observed in the driveway at this location.

The DOT&PF installed 24-inch CSP culverts in the gravel drives to Lot [REDACTED] and Lot [REDACTED]. The 24-inch culverts are located at the approximate toe-of-slope where roadway fill from the Richardson Highway meets the existing ground. The elevation of the 24-inch culverts is noticeably higher than the elevation of the drainage pathway, and as a result the culverts do not typically convey any runoff. The elevation of the 24-inch culvert in Lot 8 is approximately equal to the elevation at the house, meaning floodwaters nearly reach the structure before any meaningful flow is conveyed through the culvert along the highway. The previous owner of Lot [REDACTED] had coordinated with DOT&PF to dig a ditch on the east side of the house that would intercept runoff and convey it south towards the Richardson Highway and the 24-inch culvert in the driveway. However, the elevation of the 24-inch culvert is higher than the natural ground elevation to the east of the house.

The existing hydrologic features are shown on Figure 1 (attached). The assumed direction of groundwater flow is from east to west, following the general direction of surface water flow. This is documented on the property plats obtained from the City of Valdez.
