**SECTION 905(b) (WRDA 86) ANALYSIS
KENAI RIVER BLUFF EROSION, ALASKA**

KENAI RIVER BANK EROSION
TECHNICAL REPORT
KENAI, ALASKA

GEOTECHNICAL INVESTIGATION AND SITE CONDITIONS REPORT

KENAI RIVER BLUFF EROSION

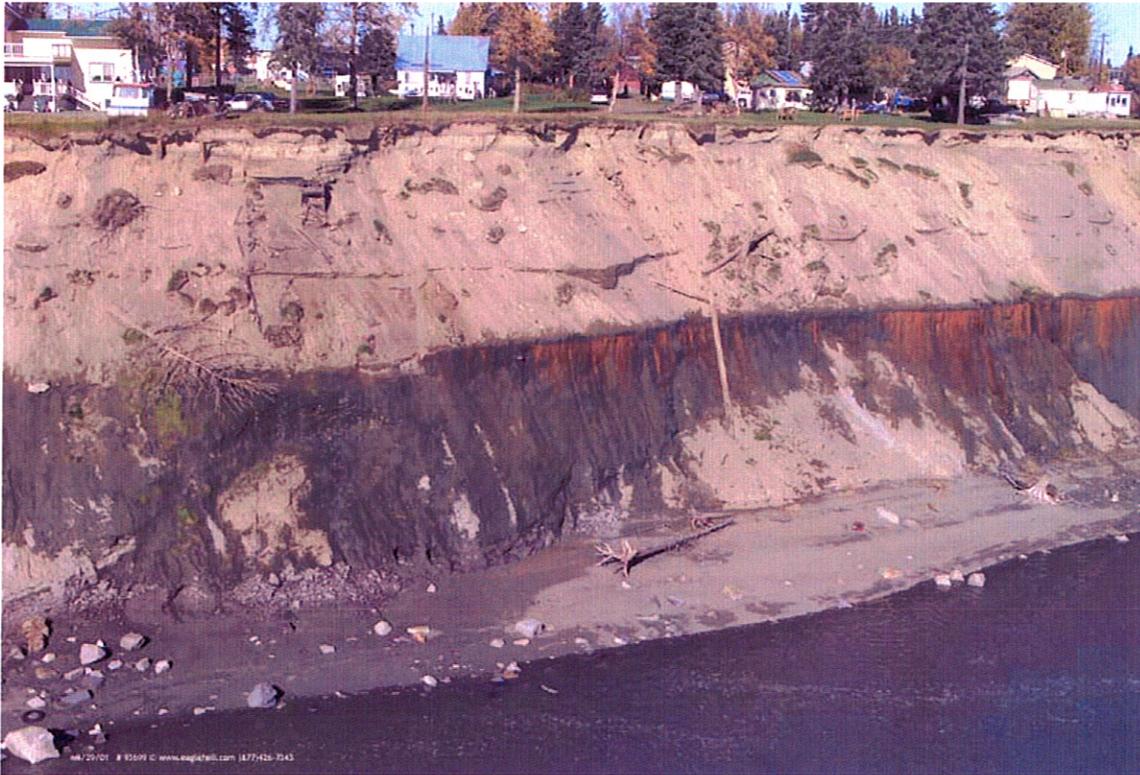
Figure 2. Typical Eroded Bluff Section

(1) Existing Conditions. The town of Kenai is located along the north bank bluff of the Kenai River at its mouth in Cook Inlet. Erosion of the bluff has continued to encroach upon city, commercial, and private utilities and structures. The Kenai bluffs are 55 to 70 feet high and are made up of poorly graded sands overlying hard, over-consolidated silt and clay. A typical section of eroded bluff is shown on Figure 2. The primary mechanism of erosion is ground water seepage at the interface between sandy and silt/clay soil layers. Other erosion mechanisms include waves and river currents undermining the fractured silt/clay layer, surface runoff, wind scour, and freeze/thaw cycles. Erosion has also resulted in properties and structures being abandoned or condemned. The city has had to relocate utilities and roads and cannot move forward with planning and development of the area.
